IMPROVING THE RESILIENCE OF EXISTING HOUSING TO SEVERE WIND EVENTS

Annual project report 2014-2015

Daniel Smith^{1,3}, David Henderson^{1,3}, John Ginger^{1,3}, Martin Wehner^{2,3}

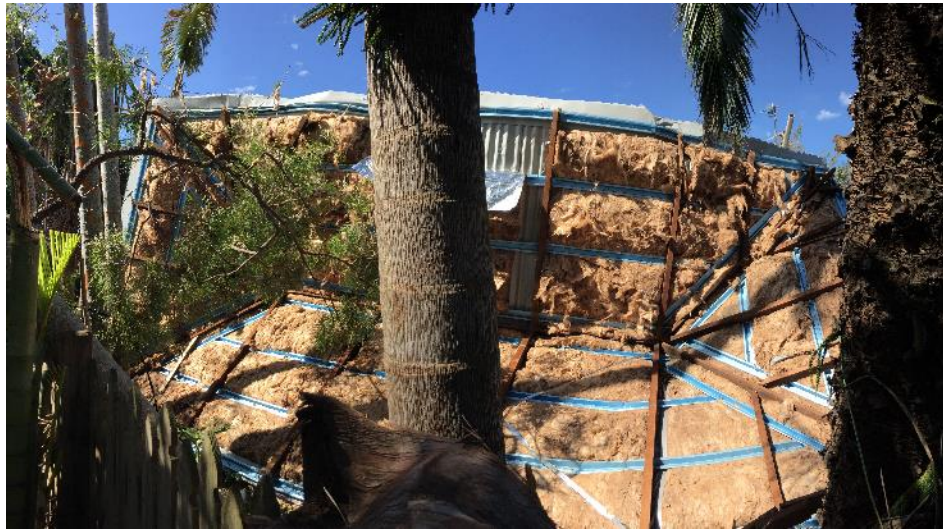
FIGURE 1. WIND-INDUCED FAILURE OF A NEW (< 1 YEAR) METAL CLADDING ROOF ON AN OLD HOUSE AT THE RAFTER TO TOP-PLATE CONNECTION DURING CYCLONE MARCIA (2015) IN YEPPON, AUSTRALIA - THERE APPEARED TO BE NO RETROFITTING OF THE WEAKER CONNECTIONS.

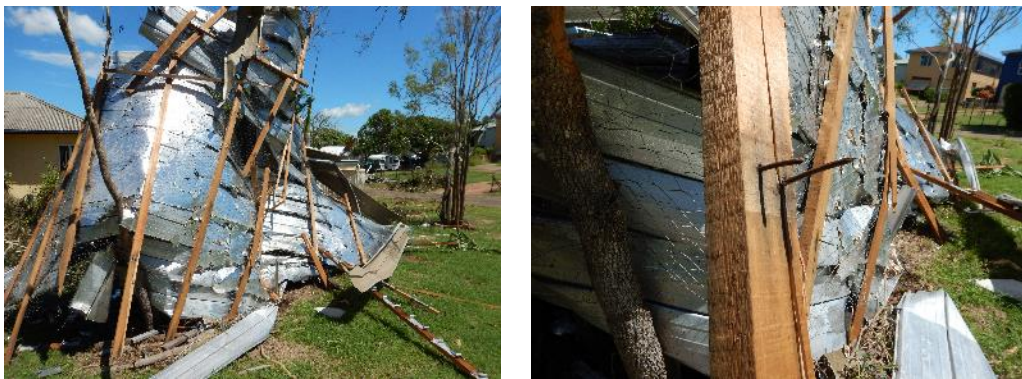
FIGURE 2. WIND-INDUCED FAILURE OF A METAL CLADDING ROOF (LEFT) AT THE BATTEN TO RAFTER CONNECTION (RIGHT) DURING CYCLONE MARCIA (2015) IN YEPPON, AUSTRALIA.

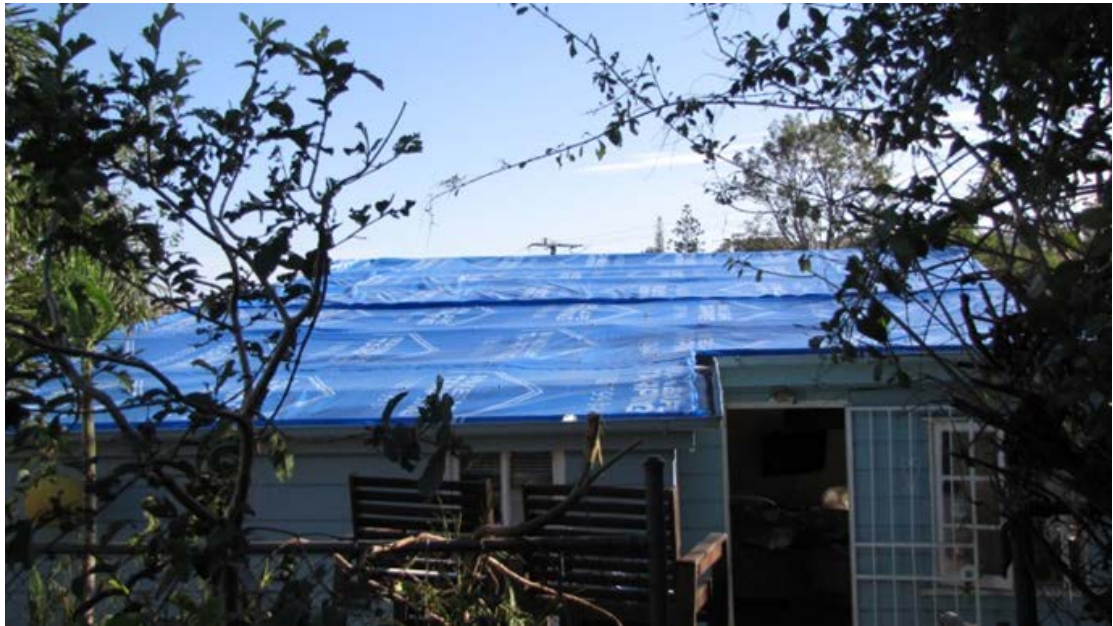
FIGURE 3. FAILED HOUSING AFTER BRISBANE THUNDERSTORMS (NOVEMBER 2014) WITH MISSING ROOFING FROM NOT IMPROVING THE BATTEN TO RAFTER CONNECTION WHEN UPGRADING THE ROOFING TO BATTEN CONNECTION (EXAMPLE 1)

The issues of poor construction practices in renovation, degradation of materials (lack of advice for maintenance), etc. are not constrained to northern Australia. Damage investigations in Brisbane, Dubbo and Perth revealed similar issues. Figure 3 and Figure 4 show failed housing with missing roofing from not improving the batten to rafter connection when upgrading the roofing to batten connection.

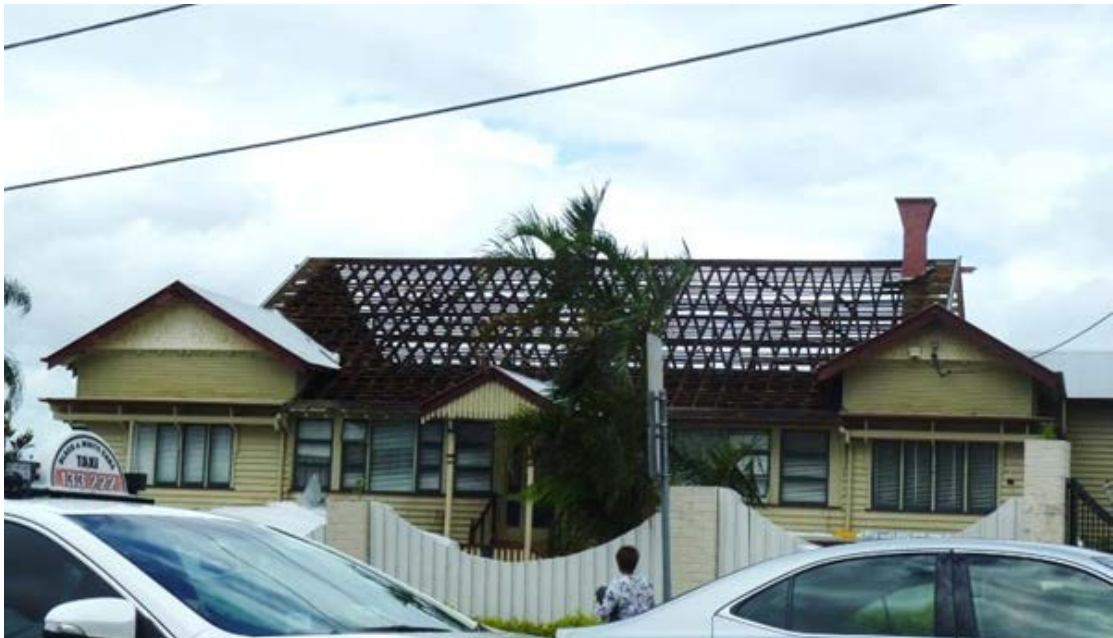
FIGURE 4. FAILED HOUSING AFTER BRISBANE THUNDERSTORMS (NOVEMBER 2014) WITH MISSING ROOFING FROM NOT IMPROVING THE BATTEN TO RAFTER CONNECTION WHEN UPGRADING THE ROOFING TO BATTEN CONNECTION (EXAMPLE 2)

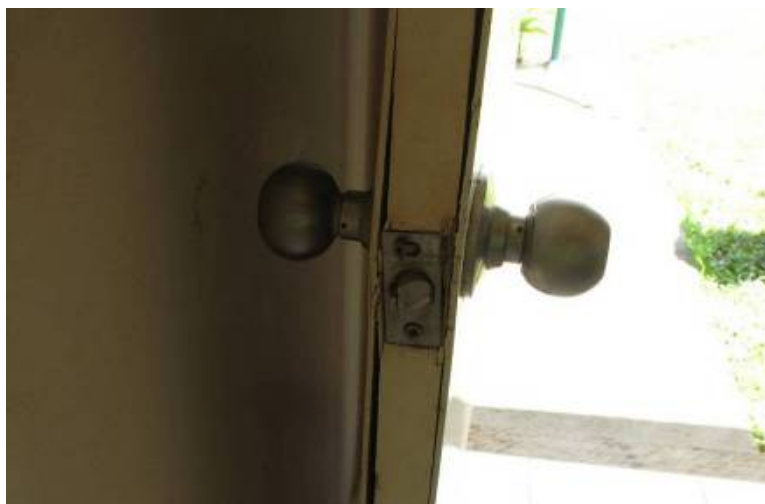
FIGURE 5. TYPICAL LOCK AND DAMAGED DOOR AFTER BEING BLOWN INWARD DURING CYCLONE YASI IN 2011.

Maintaining a sealed building envelop is critical to the wind resistance of buildings. If there is a breach on the windward face, (i.e., from broken window or failed door) (Figure 5), the internal pressure of the house can be dramatically increased. The internal loads act in concert with external pressures, increasing the load on cladding elements and the structure. Depending on the geometry of the building, the increase in internal pressure caused by this opening can double the load in certain areas, increasing the risk of failure, especially if the building has not been designed for a dominant opening.
